Indiana Department of Transportation

County Rush Route County Road 1100 N over Six Mile Creek Des. No. 1802929

FHWA-Indiana Environmental Document CATEGORICAL EXCLUSION / ENVIRONMENTAL ASSESSMENT FORM GENERAL PROJECT INFORMATION

The project involves the replacement of Rush County Bridge No. 1 carrying CR 1100 North over Six Mile Creek, approximately 0.01 mile west of CR 900 West. The project includes 249 feet of road work to the west approach, 128 feet of bridge work, 115 feet of road work to the east approach, and 50 feet of incidental work at the western terminus for a total project length of 542 feet (0.10 mile).

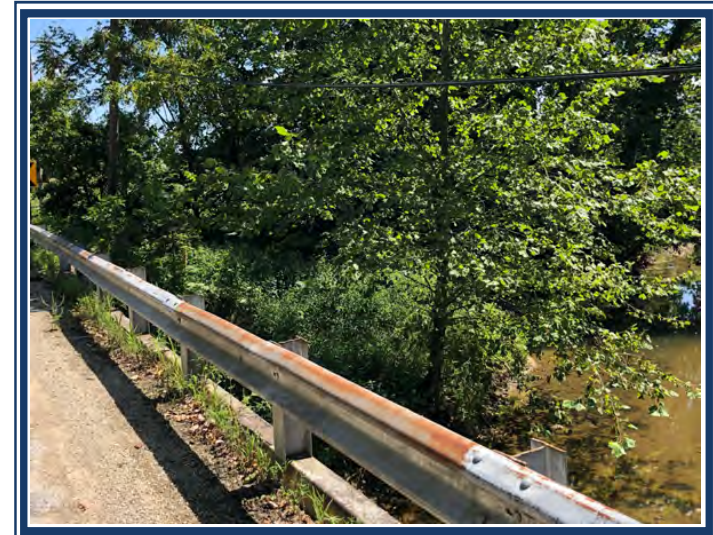
Photo 6: Looking south at the downstream side of
Rush County Bridge No. 1.

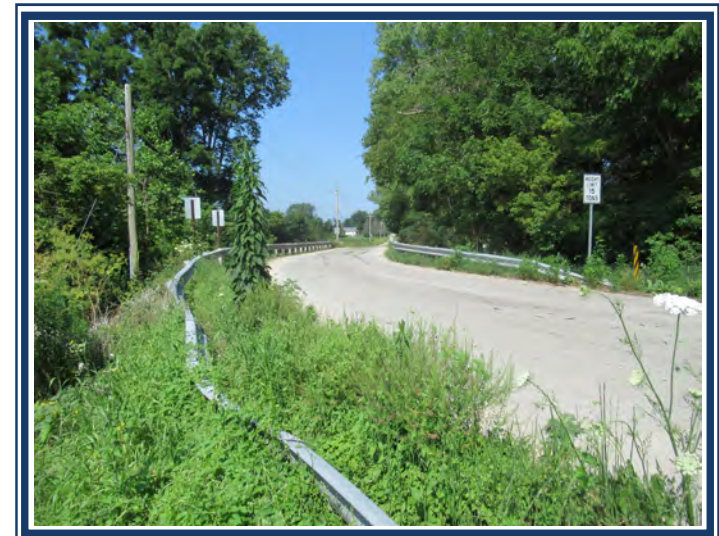
Photo 8: Guardrail damage CR 1100 N and CR 900 W
looking west towards Rush Co. Bridge No. 1.

The wearing surface and approaches both received ratings indicating poor condition. The wearing surface was given a 4 (out of 9) rating due to rutting and seepage concerns. The approaches were given a rating of 3 (out of 9) rating due to cracks and settling, in addition to a curve on the east approach. The inspection report also noted damage to the guardrail on the southeast approach.
